AIRCRAFT ACCIDENT REPORT

EASTERN AIR LINES, INC., DC-7B, N849D
IN THE ATLANTIC OCEAN 6.5 NAUTICAL MILES
SOUTH-SOUTHWEST OF JONES BEACH
LONG ISLAND, NEW YORK
FEBRUARY 8, 1965

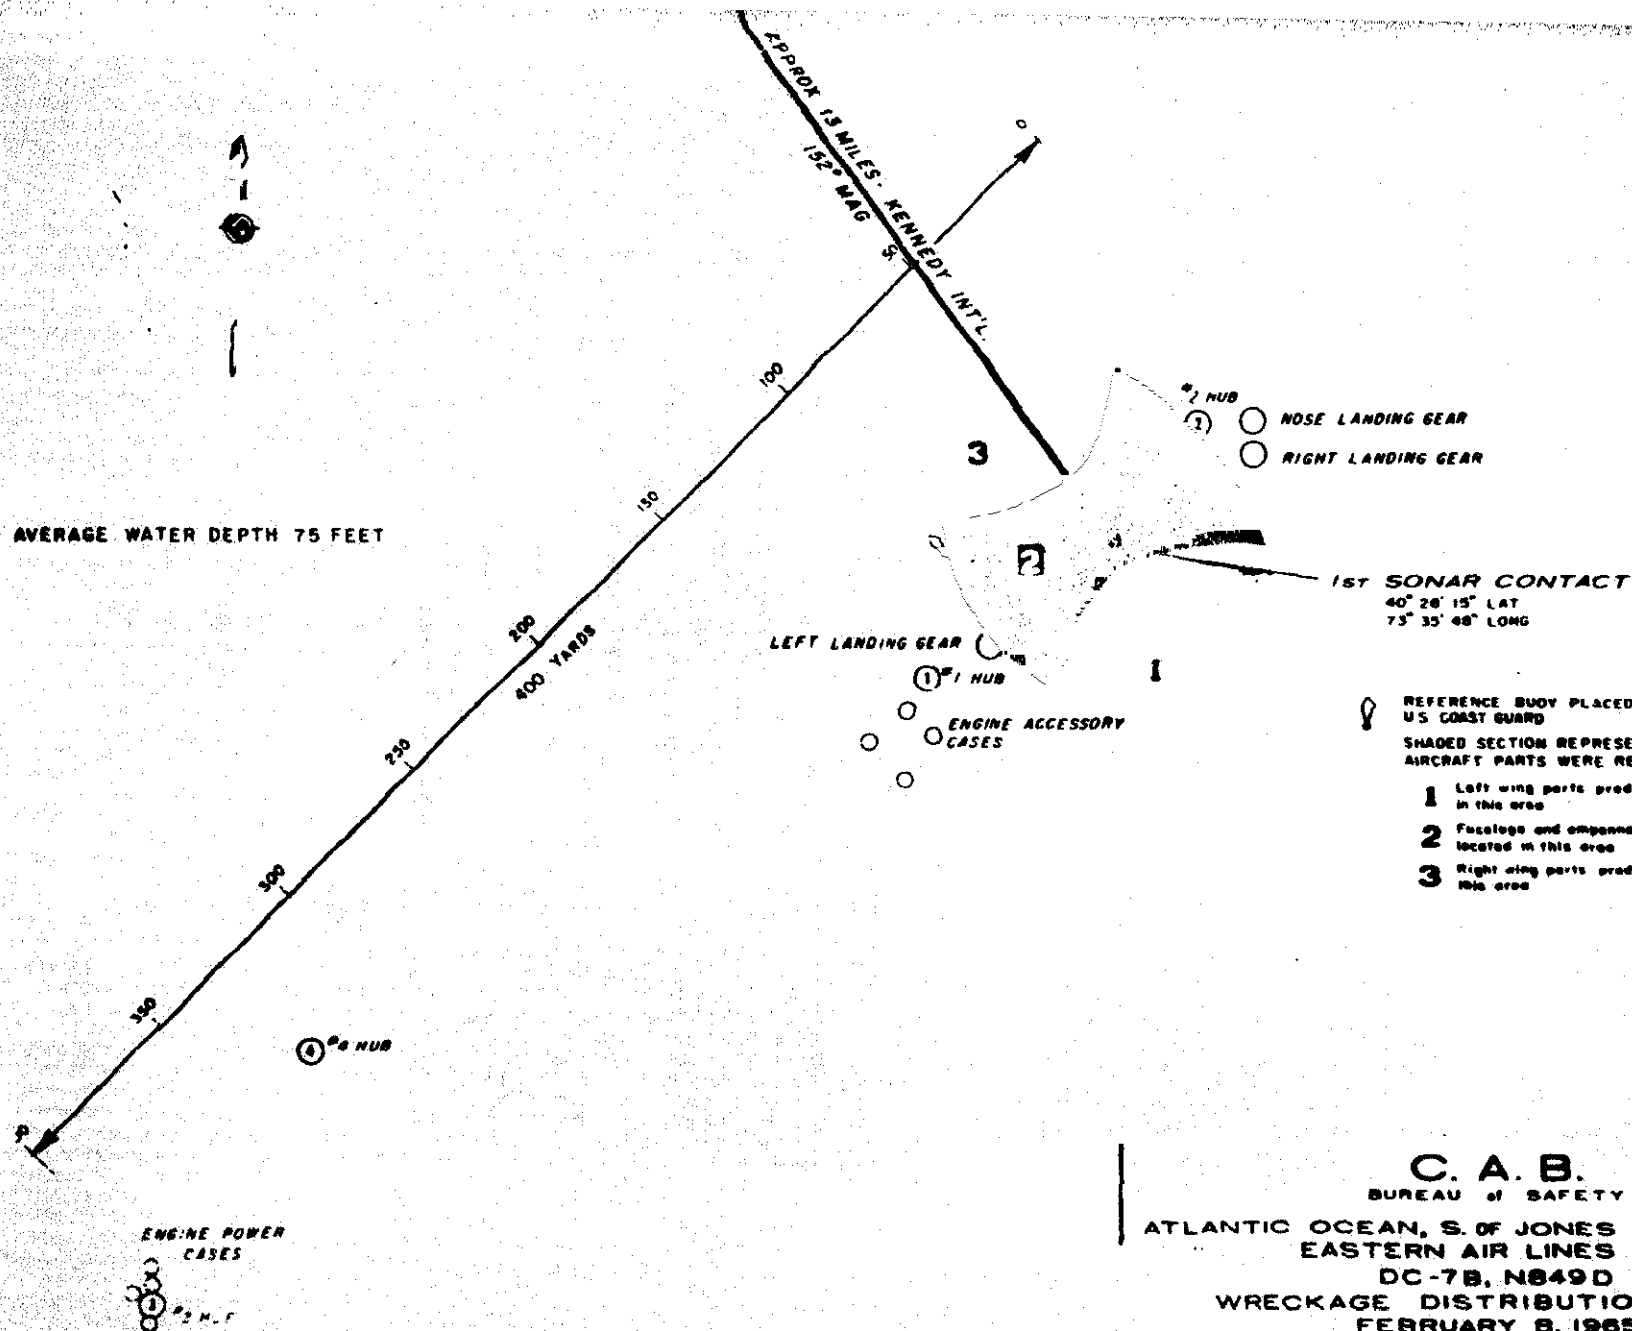
REFERENCE BUOY PLACED BY
U.S. COAST GUARD
SHADED SECTION REPRESENTS AREA WHERE
AIRCRAFT PARTS WERE RECOVERED

- 1 Left wing parts predominantly located in this area
- 2 Fuselage and empennage parts predominantly located in this area
- 3 Right wing parts predominantly located in this area
